HiLINE CORROSION PROTECTION

LONGITUDINALLY MOVEABLE PARKING PALLETS

ParkBoard PE, PH

1. System-specific corrosion protection

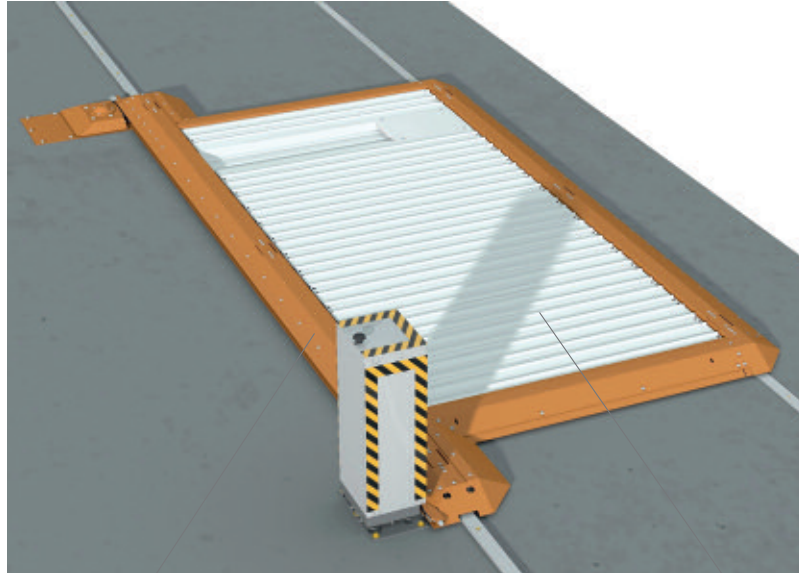
Frame construction

Platform base sections

Platform base sections:

EasyWalk:

Hot galvanized according to DIN EN ISO 1461, layer thickness min. 45 µm.

Frame construction:

Hot galvanized according to DIN EN ISO 1461, layer thickness min. 55 µm with additional orange powder coating (epoxide/polyester base) RAL 2000, dry film thickness approx. 60 – 80 µm.

Cross members:

Hot galvanized according to DIN EN ISO 1461, layer thickness min. 55 µm.

Rail system:
